# **Retention of Pre-construction Primer in Tank Coating Systems**

**NSRP Project 3-96-3**

**November 2002**

**PREPARED BY:  
ASSOCIATED COATINGS CONSULTANTS, INC.  
And  
NATIONAL STEEL AND SHIPBUILDING  
IN COOPERATION WITH  
FRIEDE GOLDMAN HALTER  
GULFPORT, MS**

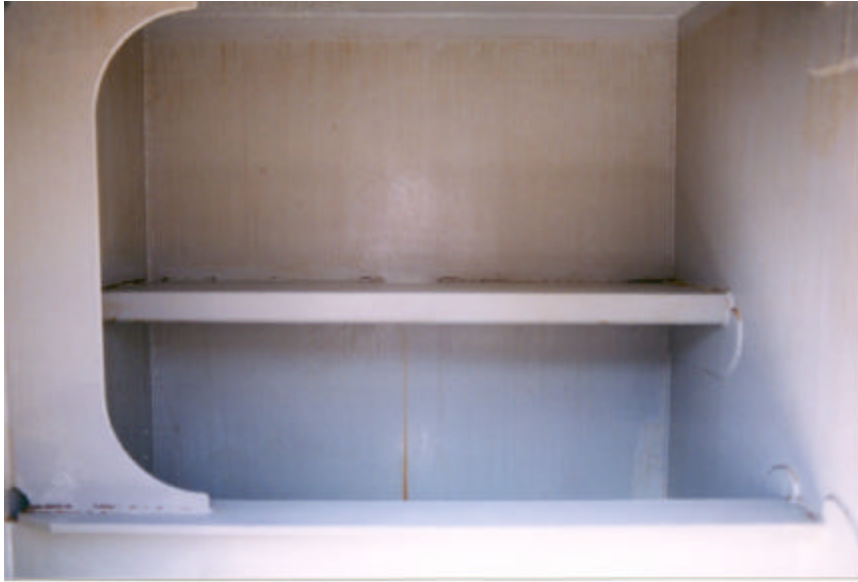
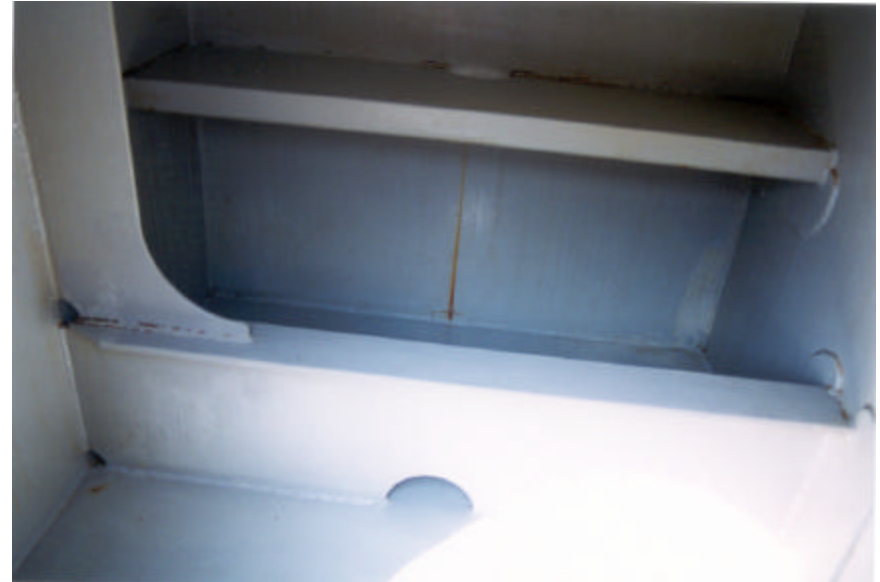
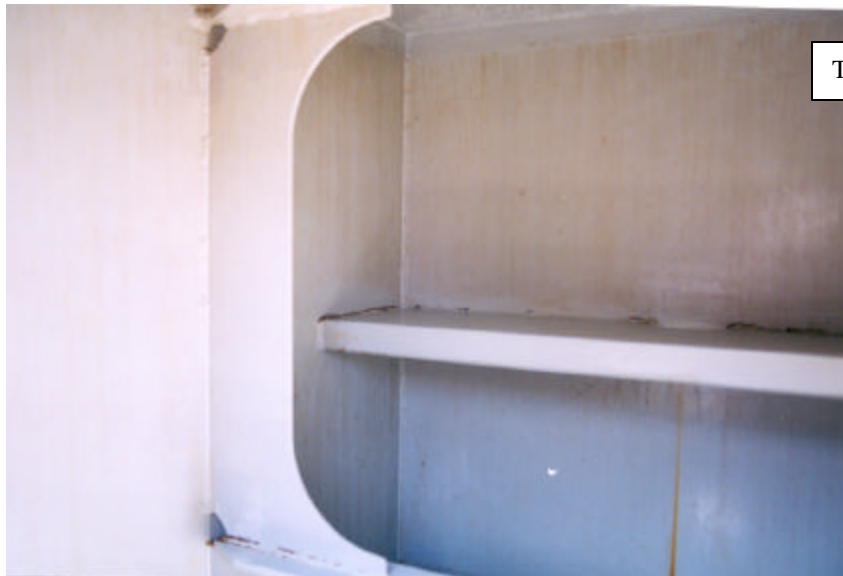
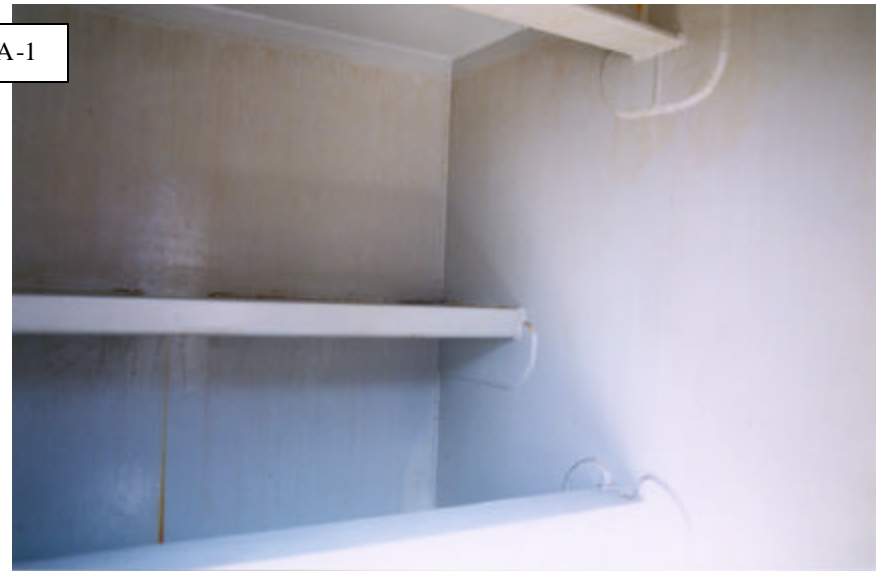
Tank A-1

Tank A was pre-primed with a 52% zinc load, solvent-based material. All secondary surface preparation of welds and damaged areas was accomplished with power tools. Cell A-1 was topcoated with a 93 % volume solids epoxy from the same supplier as the primer. There were no significant failures in this cell. There were only a total of seven pinholes with rust in the entire tank.

<b>Tank A1- Primer #1 (52% Zinc) &amp; Topcoat A (93% Volume Solids) From Same Supplier</b>						
<b>Surface Preparation Initial: SSPC SP-10</b>			<b>Secondary: Power Tool, SSPC SP-3</b>			<b>Total Dry Film Thickness: 10-27 mils</b>
<b>Surface Graded</b>	<b>ASTM D-610 Rust</b>	<b>ASTM F1130 Inspection</b>	<b>ASTM D-714 Blistering</b>	<b>CLER Condition</b>	<b>Edge Failure</b>	<b>Remarks</b>
Top - Flat	10	0	None	1	None	
Top - Stiffener	9S	1B	None	1	None	One pin hole at weld
Top - Fill Port	9S	1B	None	1	None	
Back - Flats	9S	1B	None	1	None	One pin hole at weld
Back - Stiffener (HP)	9S (UNDER)	1B	None	1	None	Two pin holes underside only
Bottom - Flats	9S	1B	None	1	None	Four pin holes
Bottom - Stiffener	10	0	None	1	None	Mechanical damage one spot (1/4 inch diameter)
Bottom - Drain	10	0	None	1	None	Rust stain only
Right Side - Flat	10	0	None	1	None	
Left Side - Flat	10	0	None	1	None	
Side Structure	10	0	None	1	None

Front Flat	10	0	None	1	None	
Hatch	10	0	None	1	None	Rust stain only
Additional Remarks:

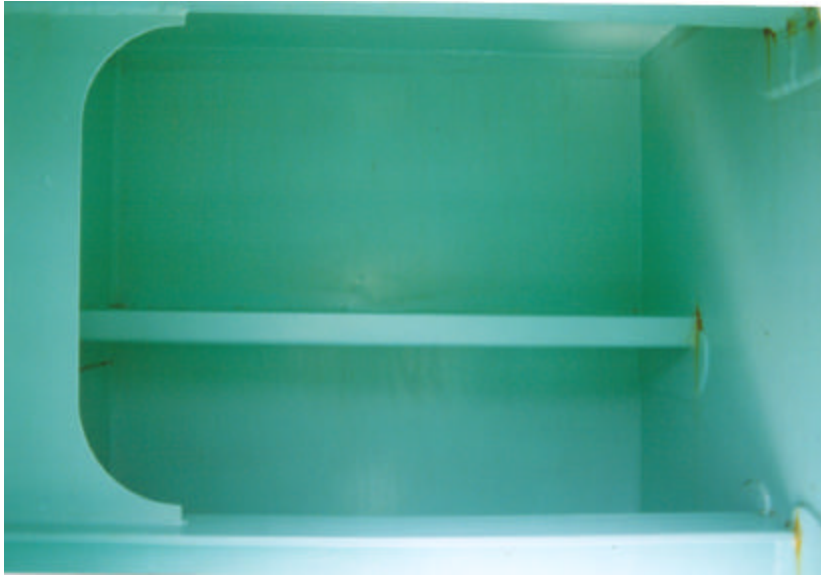
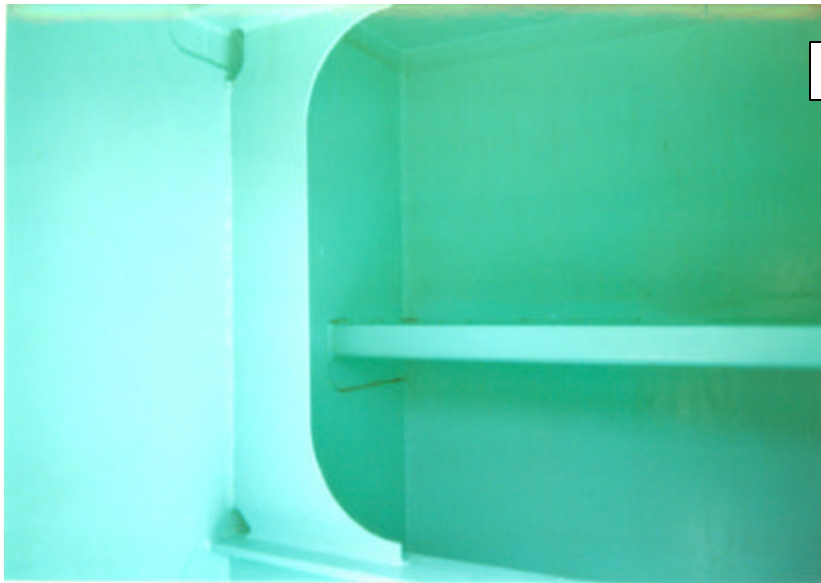
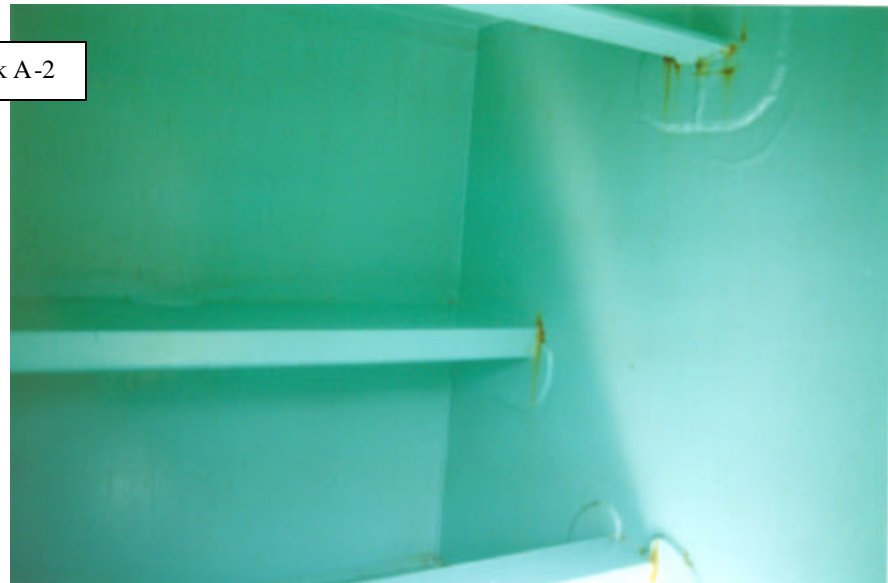
Tank A-2

Cell A-2 was topcoated with a 98% solids material. This material was qualified to Mil-P-23238 as a edge retentive epoxy. The material had also passed MARINTEK qualification. The only failure was associated with minor cracking at a weld on the right flat.

<b>Tank A2- Primer #1 (52% Zinc) &amp; Topcoat B (98% Volume Solids) From Different Suppliers</b>						
<b>Surface Preparation Initial: SSPC SP-10</b>			<b>Secondary: Power Tool, SSPC SP-3</b>			<b>Total Dry Film Thickness: 10-24 mils</b>
<b>Surface Graded</b>	<b>ASTM D-610 Rust</b>	<b>ASTM F1130 Inspection</b>	<b>ASTM D-714 Blistering</b>	<b>CLER Condition</b>	<b>Edge Failure</b>	<b>Remarks</b>
Top - Flat	10	0	None	1	None	
Top - Stiffener	10	0	None	1	None	
Top - Fill Port	9S	1B	None	1	None	
Back - Flats	10	0	None	1	None	
Back - Stiffener (HP)	10	0	None	1	None	
Bottom - Flats	10	0	None	1	None	
Bottom - Stiffener	10	0	None	1	None	
Bottom - Drain	10	0	None	1	None	Rust stain
Right Side - Flat	8G	6C	None	1	None	Failure limited to cracking at welds. SP-3 SP*
Left Side - Flat	10	0	None	1	None	
Side Structure	10	0	None	1	None	
Front Flat	10	0	None	1	None	
Hatch	10	0	None	1	None	Rust stain
Additional Remarks: Surface preparation at welds was SSPC SP-3, Power Tool Cleaning

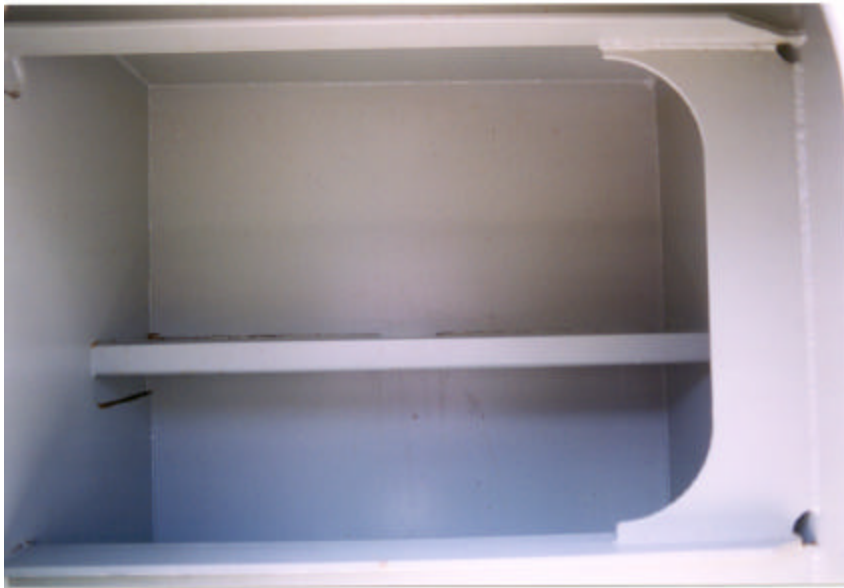
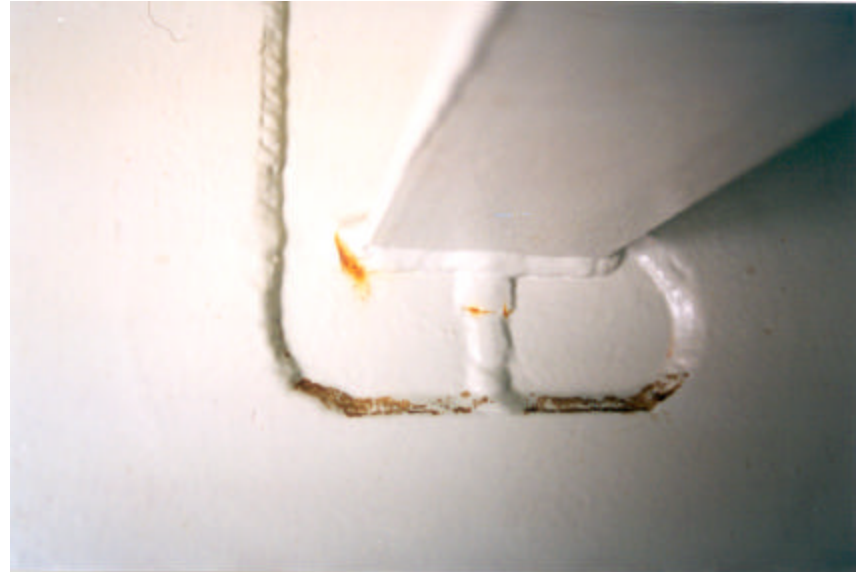
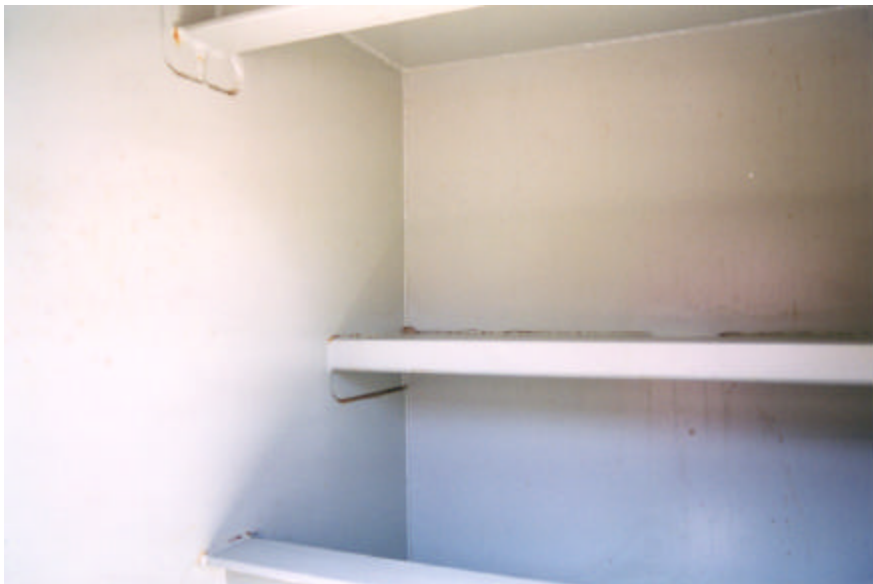
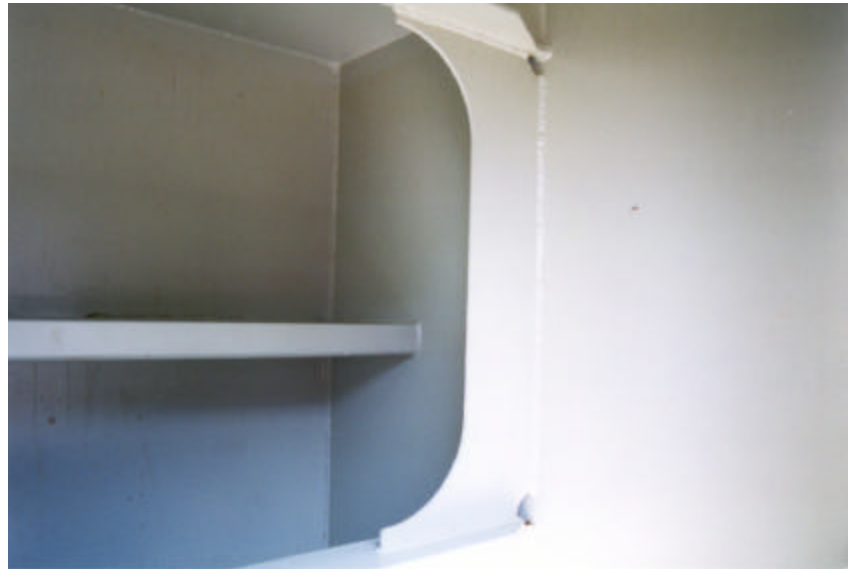
Tank A-3

Cell A-3 was topcoated with a 67% solids material. Only three pinholes showed any rust. There was minor cracking at one weld.

<b>Tank A3- Primer #1 (52% Zinc) &amp; Topcoat C (67% Volume Solids) From Different Suppliers</b>						
<b>Surface Preparation Initial: SSPC SP-10</b>			<b>Secondary: Power Tool, SSPC SP-3</b>			<b>Total Dry Film Thickness: 11-20 mils</b>
<b>Surface Graded</b>	<b>ASTM D-610 Rust</b>	<b>ASTM F1130 Inspection</b>	<b>ASTM D-714 Blistering</b>	<b>CLER Condition</b>	<b>Edge Failure</b>	<b>Remarks</b>
Top - Flat	10	0	None	1	None	
Top - Stiffener	10	0	None	1	None	
Top - Fill Port	6S	4T	None	1	None	
Back - Flats	10	0	None	1	None	
Back - Stiffener (HP)	10	0	None	1	None	
Bottom - Flats	9S	1B	None	1	None	Three pin holes
Bottom - Stiffener	9S	1B	None	1	None	Mechanical damage - one spot
Bottom - Drain	10	0	None	1	None	Mechanical damage - one spot
Right Side - Flat	10	0	None	1	None	
Left Side - Flat	9S	1B	None	1	None	Cracking at weld
Side Structure	10	0	None	1	None	
Front Flat	10	0	None	1	None	Mechanical damage
Hatch	10	0	None	1	None	Rust stain

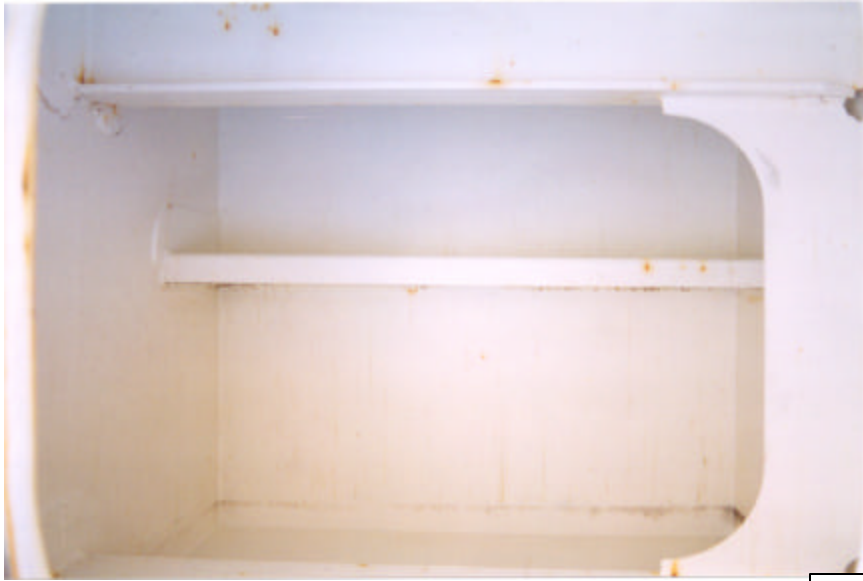
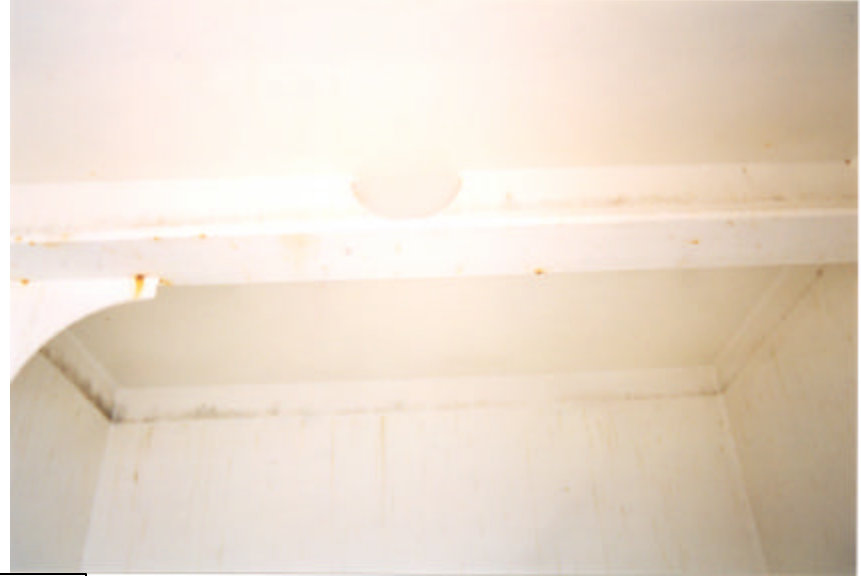
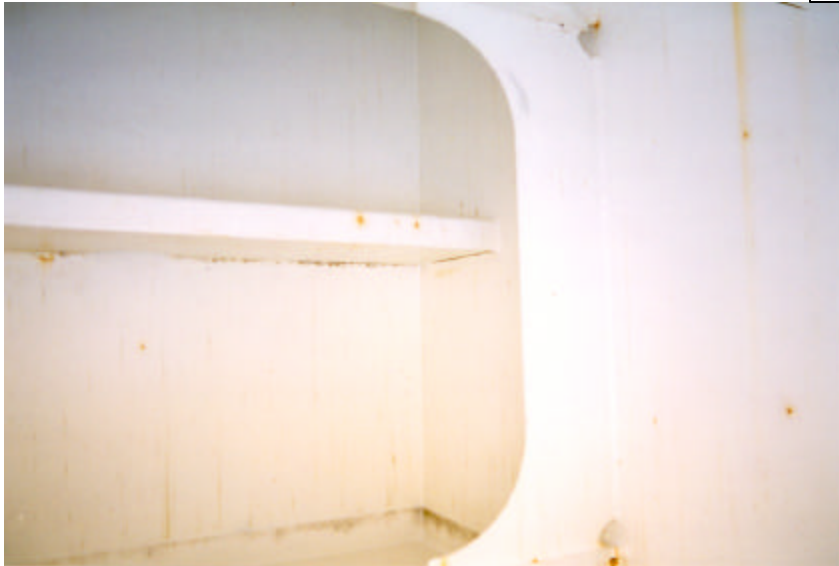
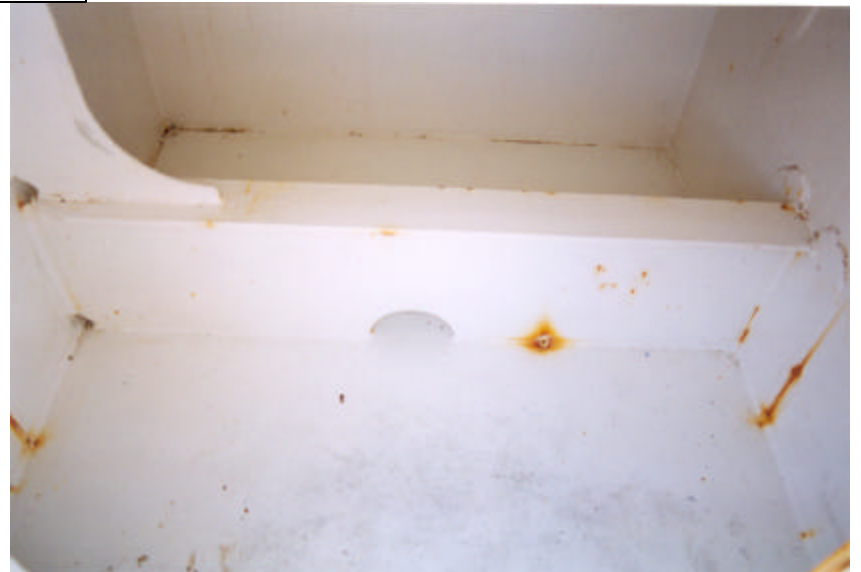
Tank B-1

Cell B-1 was topcoated with a high solids (98% volume solids) topcoat from the same supplier. Because of manufacturing problems, this material was subsequently removed from the market. Most of the failures were associated with failure at the welds. Some cracking at welds was observed.

<b>Tank B-1- Primer #2 (Waterborne)(85% Zinc) &amp; Topcoat D (98% Volume Solids)</b>						
<b>Surface Preparation Initial: SSPC SP-10</b>			<b>Secondary: Power Tool, SSPC SP-3</b>			<b>Total Dry Film Thickness: 15-18 mils</b>
<b>Surface Graded</b>	<b>ASTM D-610 Rust</b>	<b>ASTM F1130 Inspection</b>	<b>ASTM D-714 Blistering</b>	<b>CLER Condition</b>	<b>Edge Failure</b>	<b>Remarks</b>
Top - Flat	10	0	None	1	None	
Top - Stiffener	9S	1B	None	1	None	
Top - Fill Port	8T	2G	None	3	None	Threads only
Back - Flats	9S	1B	None	1	None	1 crack at weld 0.75 inches long
Back - Stiffener (HP)	9G	1B	None	1	None	
Bottom - Flats	9S	1B	None	1	None	
Bottom - Stiffener	9G	1B	None	1	None	Mechanical damage 3 spots
Bottom - Drain	10	0	None	1	None	Rust stains
Right Side - Flat	9S	1B	None	1	None	Some cracking around welds
Left Side - Flat	9S	1B	None	1	None	Most failures at welds
Side Structure	9S	1B	None	1	None	Failure at some welds

Front Flat	10	0	None	1	None	Mechanical damage at hatch
Hatch	10	0	None	1	None	Rust stains
Additional Remarks: Most failures are associated with welds, with some apparent cracking

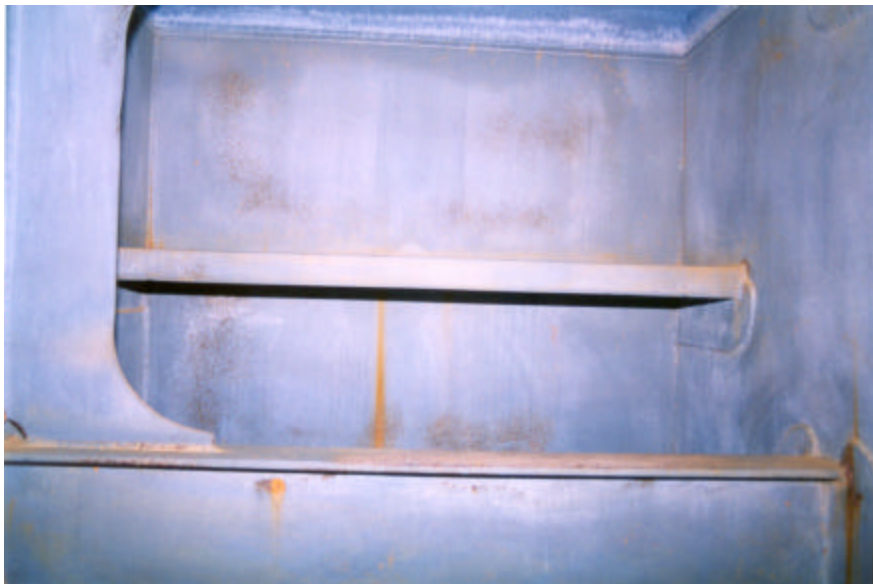
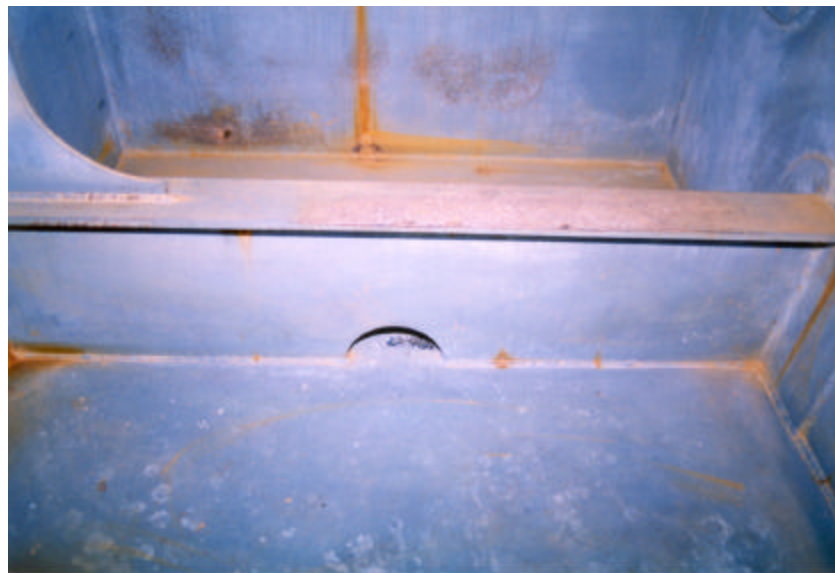
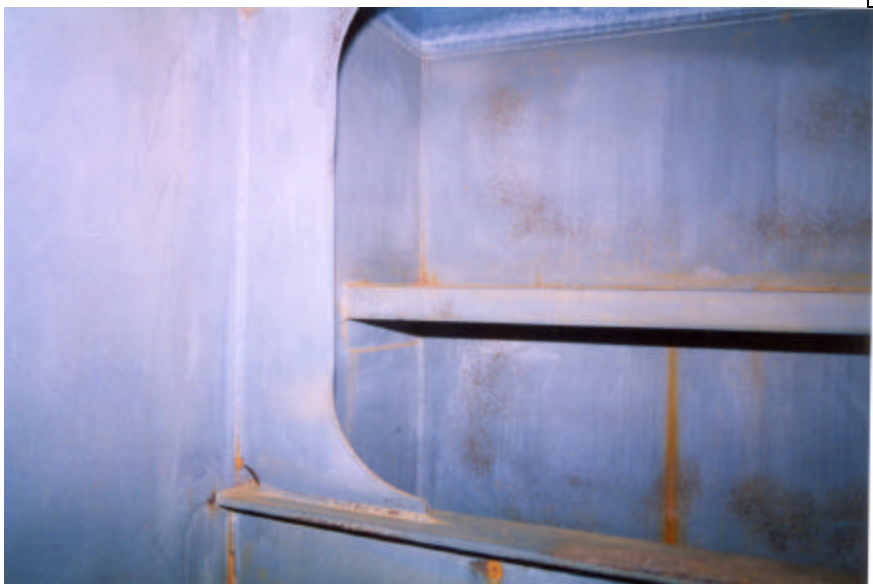
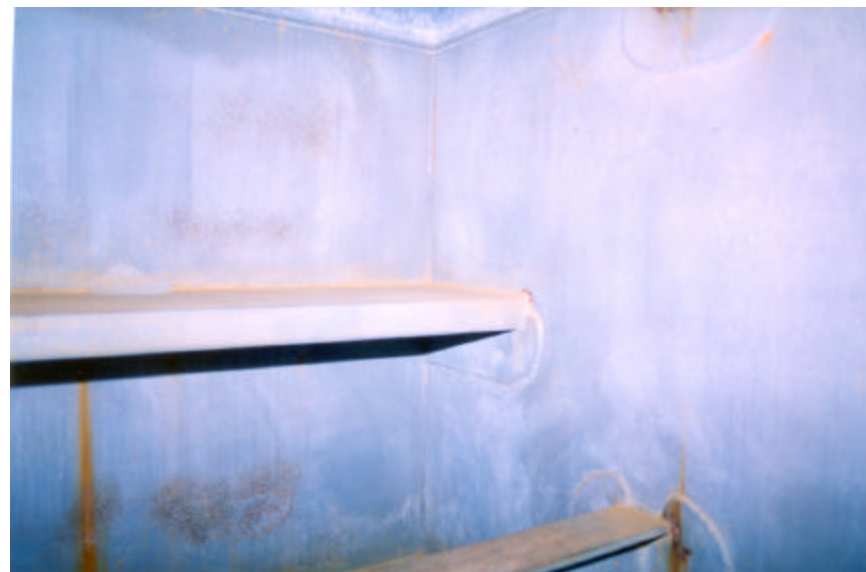
Tank B-2

Cell B-2 was topcoated with a full thickness, waterborne, high ration inorganic zinc topcoat. There was some failure associated with some of the power tool cleaned welds; however, the primary failure mode was erosion and depletion of the zinc. The zinc acted as an anode, which sacrificed to the protected steel. Had a zinc anode been used in conjunction with this system, the system longevity would have increased. This was the case in a previous NSRP Tank Lining test program (3-93-1) where a solvent based inorganic zinc with zinc anode cathodic protection demonstrated no failure after six years of testing.

<b>Tank B-2- Primer #2 (Waterborne)(85% Zinc)&amp; Waterborne Inorganic Zinc Topcoat From Same Supplier</b>						
<b>Surface Preparation Initial: SSPC SP-10</b>			<b>Secondary: Sweep Blast SSPC SP-7</b>			<b>Total Dry Film Thickness: 2-3.4 mils</b>
<b>Surface Graded</b>	<b>ASTM D-610 Rust</b>	<b>ASTM F 1130 Inspection</b>	<b>ASTM D-714 Blistering</b>	<b>CLER Condition</b>	<b>Edge Failure</b>	<b>Remarks</b>
Top - Flat	10	0	None	1	None	
Top - Stiffener	6G	10F	None	2	None	Major failure limited to top edge
Top - Fill Port	3G	7M	None	2	None	Threads only
Back - Flats	5P	11H	None	2	None	
Back - Stiffener (HP)	9S/5P	11H	None	2	None	Bottom 9S/Top 5P
Bottom - Flats	6P*	11H	None	2	None	Coating depleted in one square foot at drain
Bottom - Stiffener	1P/8P	11G	None	2	None	Top flange 1P/Underside 1P/Back of web 8P
Bottom - Drain	10	0	None	1	None	
Right Side - Flat	7P	1C	None	1	None	Welds failed
Left Side - Flat	8P	1C	None	1	None	Mud cracking, excessive thickness in corner

Side Structure	8G	1D	None	1	None	
Front Flat	1P*	8P	None	2	None	Failure limited to drain area - erosion
Hatch	10	0	None	1	None	Rust stain
Additional Remarks: *Noted failures are localized to fill port and low thickness around hatch.

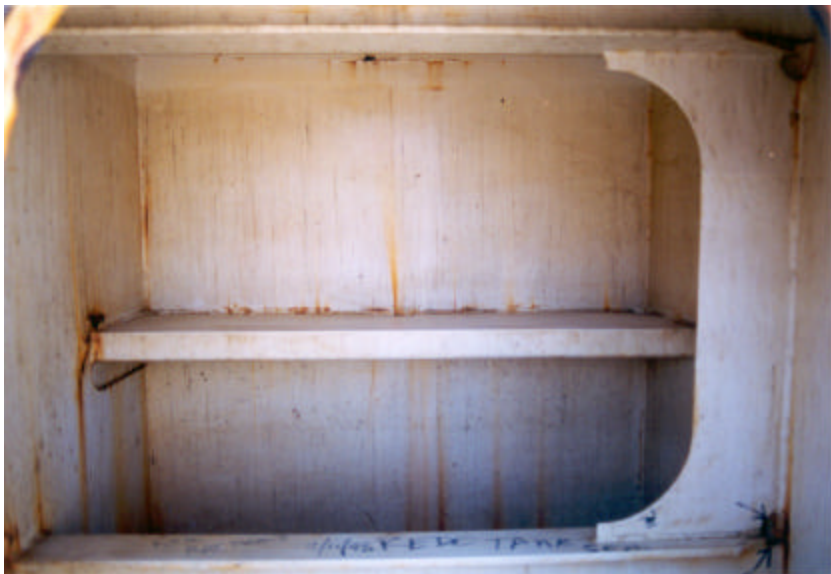
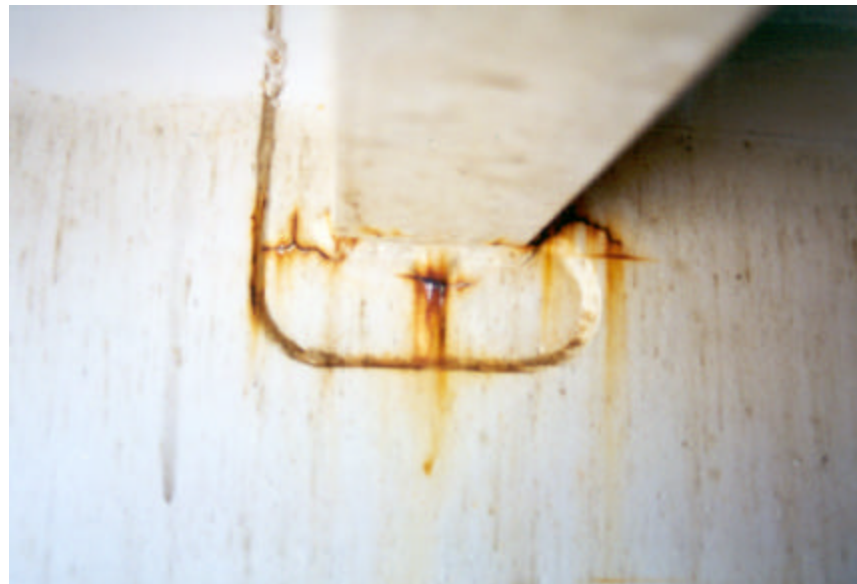
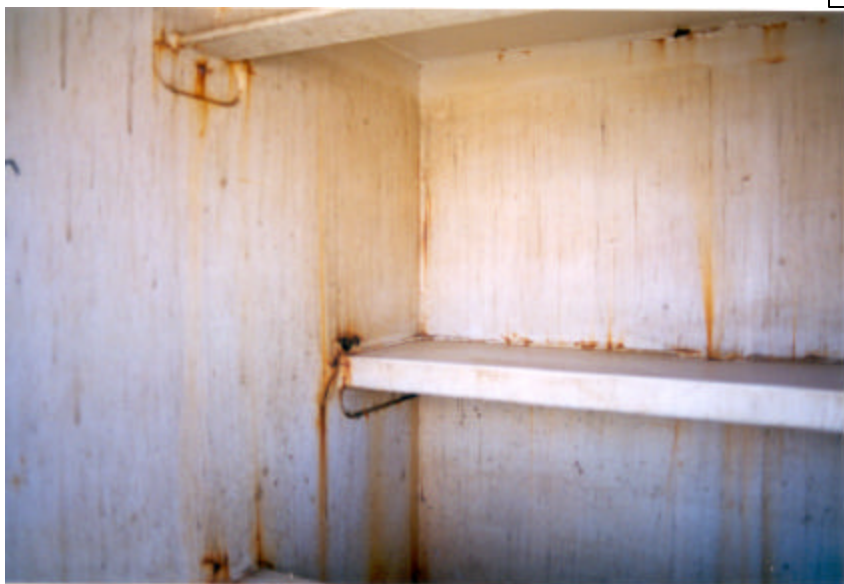
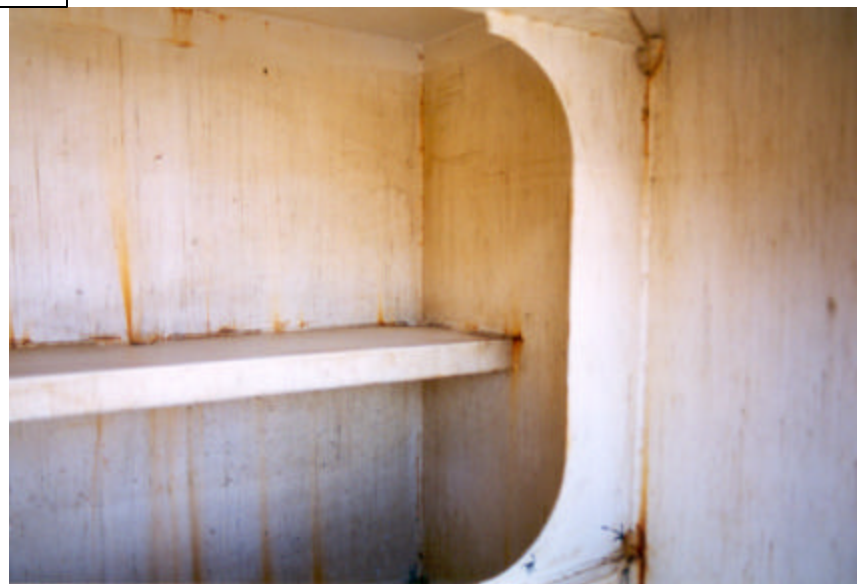
Tank B-3

Cell B-3 was topcoated with an 80% solids material. Because of schedule constraints, this tank was not completed properly. Many pinholes and holidays were identified but not repaired prior to placing the tank under test. As a result, defects began to appear early in the program. The lesson learned here is that attention to detail in assuring the job is complete is at least as important as the lining selection. Unfortunately, this is the only tank coated with this product so that no comparisons could be made over an alternate PCP.

<b>Tank B-3- Primer #2 (Waterborne)(85% Zinc) &amp; Topcoat E (80% Volume Solids) From Different Suppliers</b>						
<b>Surface Preparation Initial: SSPC SP-10</b>			<b>Secondary: Power Tool, SSPC SP-3</b>			<b>Total Dry Film Thickness: 6-11 mils</b>
<b>Surface Graded</b>	<b>ASTM D-610 Rust</b>	<b>ASTM F1130 Inspection</b>	<b>ASTM D-714 Blistering</b>	<b>CLER Condition</b>	<b>Edge Failure</b>	<b>Remarks</b>
Top - Flat	6S	1N	None	2	None	Cracking around snipe. Starting to crack at weld. Backside in particular
Top - Stiffener	8S	5G	None	2	None	
Top - Fill Port	3G	11S	None	2	None	Total failure at threads
Back - Flats	6G	11G	None	1	None	Failure limited to cracking at welds
Back - Stiffener (HP)	8S	1B	None	1	None	One crack
Bottom - Flats	3S	11J	None	2	None	Failure limited to cracking at welds
Bottom - Stiffener	8S/3G/8G	6M	None	2	None	Flange top 8S/underside 3G/Web 8G
Bottom - Drain	10	0	None	1	None	
Right Side - Flat	9S	1B	None	1	None	Failure at welds

Left Side - Flat	3S	11J	None	2	None	
Side Structure	6G	7H	None	2	None	Failure limited to backside. Insufficient coating.
Front Flat	7G	8B	None	1	None	
Hatch	9G	11C	None	1	None	
Additional Remarks:

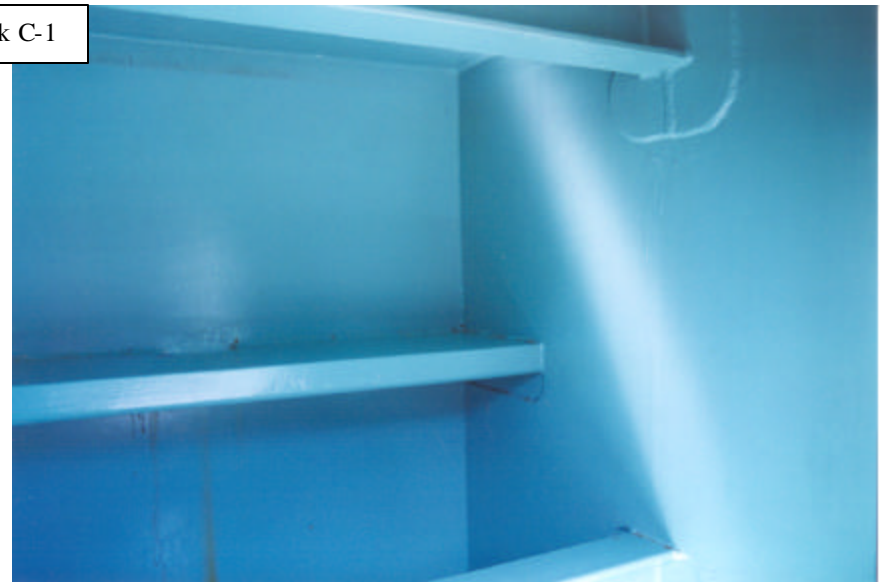
Tank C-1

The systems in Cells C-1 and C-3 performed essentially the same. Both tanks had cracking at the welds, except that there was more cracking at the welds in the tank where the welds had been power tool cleaned. There was no failure associated with the PCP since the failures were limited to repair areas, which had no PCP present. Some minor blistering was experienced in the control tank (C-3) but this was associated with areas of low film thickness. These two Cells provide conclusive evidence that the PCP does not degrade performance. It also demonstrates that secondary surface preparation should consist of reblast cleaning of welds and damaged areas.

<b>Tank C-1- Primer #3 (28% Zinc) &amp; Topcoat F (100% Volume Solids) From Same Supplier</b>						
<b>Surface Preparation Initial: SSPC SP-10</b>			<b>Secondary: Power Tool, SSPC SP-3</b>			<b>Total Dry Film Thickness: 10-17 mils</b>
<b>Surface Graded</b>	<b>ASTM D-610 Rust</b>	<b>ASTM F1130 Inspection</b>	<b>ASTM D-714 Blistering</b>	<b>CLER Condition</b>	<b>Edge Failure</b>	<b>Remarks</b>
Top - Flat	9S*	1B	None	1	None	Minor cracking at welds.
Top - Stiffener	10	1B	None	1	None	1 crack 0.75 inches long, backside at weld.
Top - Fill Port	4G	4S	None	1	None	
Back - Flats	9S	1B	None	1	None	
Back - Stiffener (HP)	9S	1B	None	1	None	Failure limited to welds
Bottom - Flats	9S	1B	None	1	None	
Bottom - Stiffener	9S	1B	None	1	None	
Bottom - Drain	10	0	None	1	None	Rust staining only
Right Side - Flat	10	0	None	1	None	
Left Side - Flat	9S	1B	None	1	None	Cracking not associated with weld.
Side Structure	10	0	None	1	None

Front Flat	9S	1B	None	1	None	Pinhole in weld, no rust.
Hatch	10	0	None	1	None	Staining only
Additional Remarks: *Failure associated with wet film thickness measurement. **Starting to observe micro cracking in some weld areas.

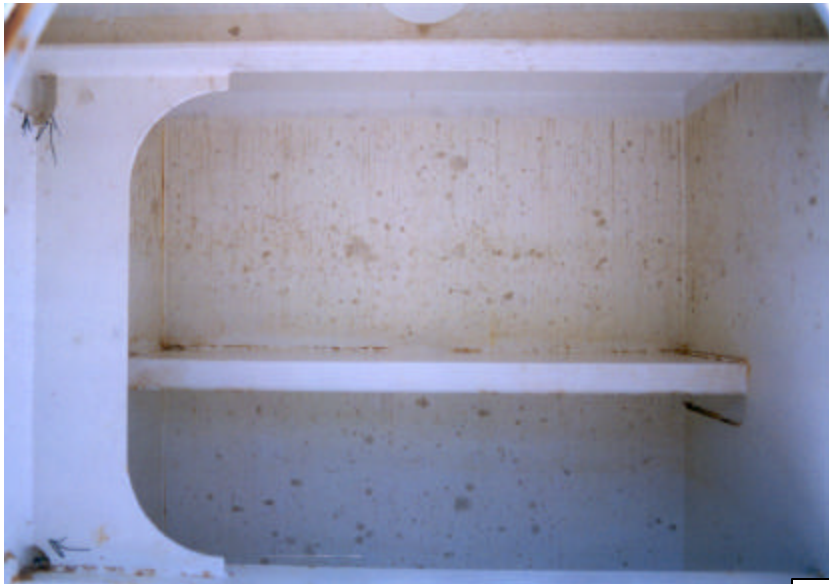
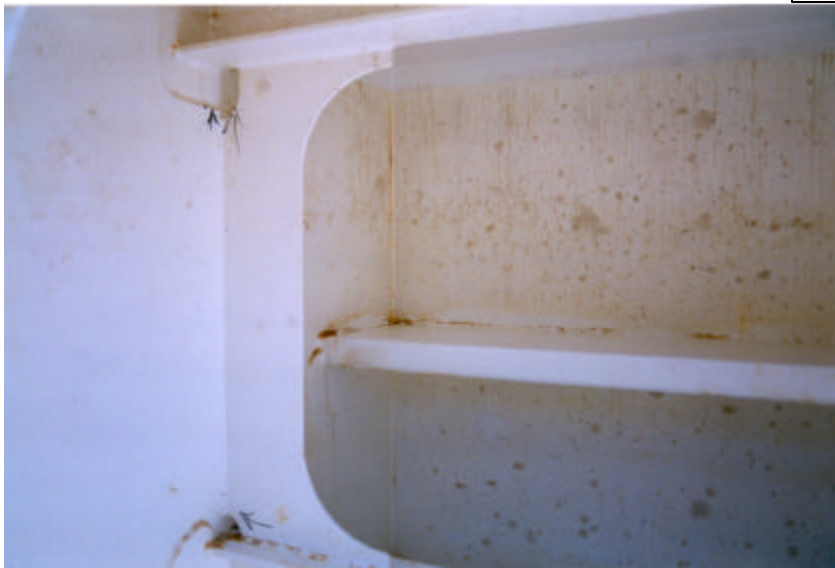
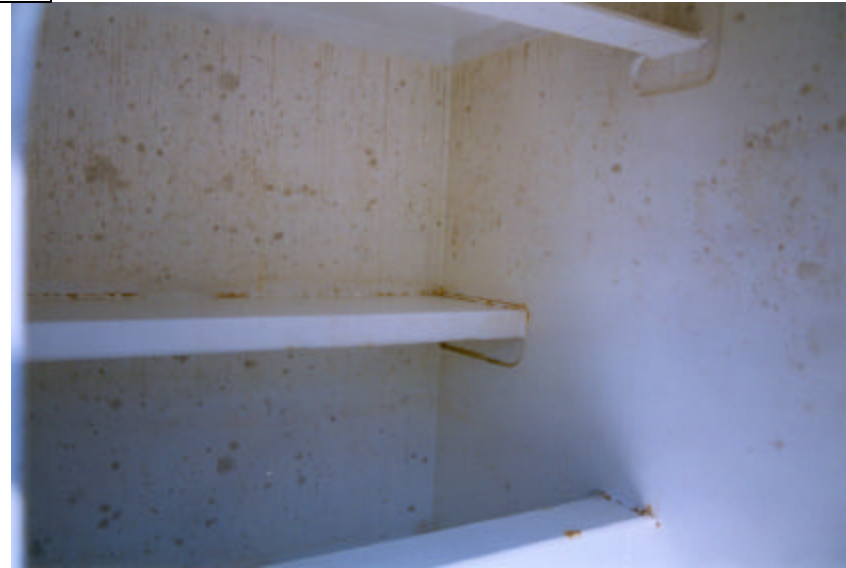
Tank C-2

<b>Tank C-2- Primer #3 (28% Zinc) &amp; Topcoat D (98% Volume Solids) From Different Suppliers</b>						
<b>Surface Preparation Initial: SSPC SP-10</b>			<b>Secondary: Power Tool, SSPC SP-3</b>			<b>Total Dry Film Thickness: 11-20 mils</b>
<b>Surface Graded</b>	<b>ASTM D-610 Rust</b>	<b>ASTM F1130 Inspection</b>	<b>ASTM D-714 Blistering</b>	<b>CLER Condition</b>	<b>Edge Failure</b>	<b>Remarks</b>
Top - Flat	9S	1B	None	1	None	
Top - Stiffener	9S	1B	None	1	None	Cracking at welds.
Top - Fill Port	4G	4S	None	1	None	
Back - Flats	10	0	None	1	None	
Back - Stiffener (HP)	9S	1B	None	1	None	All failures are cracking at welds.
Bottom - Flats	9S	1B	None	1	None	Cracking at welds, back of tank.
Bottom - Stiffener	9S	1B	None	1	None	
Bottom - Drain	4G	11P	None	2	None	Extensive cracking around lip of drainpipe.
Right Side - Flat	9S	1B	None	1	None	Cracking adjacent to weld.
Left Side - Flat	9S	1B	None	1	None	All failures associated with cracks, one crack nine inches long.

Side Structure	10	0	None	1	None	
Front Flat	9S	1B	None	1	None	Cracking at welds.
Hatch	10	0	None	1	None	Rust staining only.
Additional Remarks:

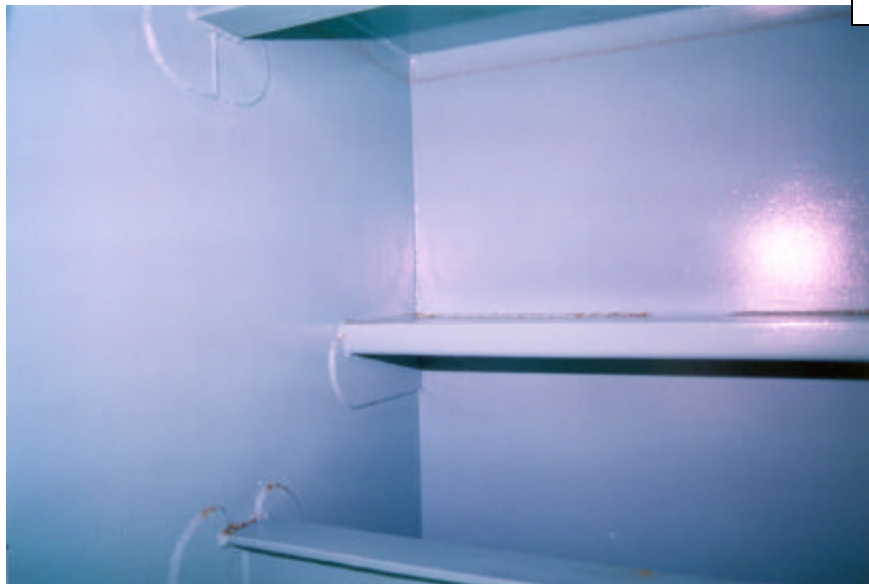
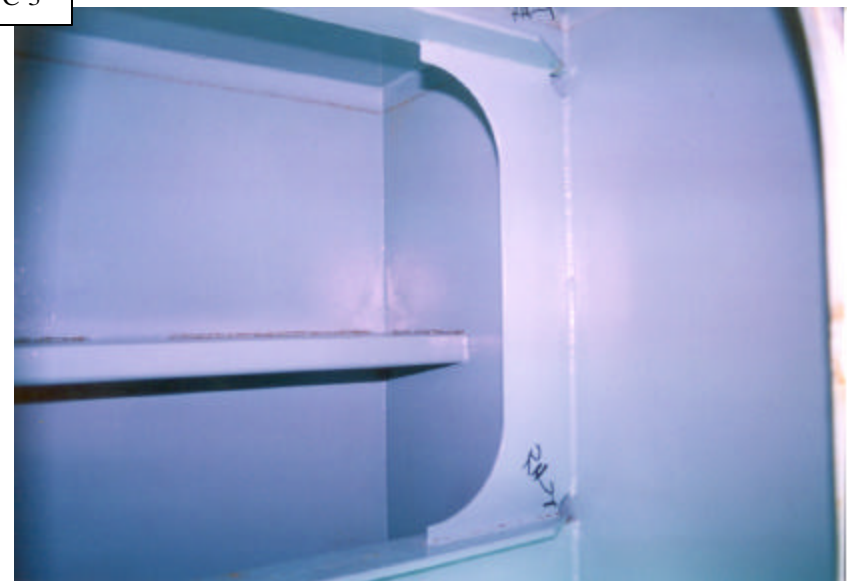
Tank C-3

Tank C-3- Control One –Primer completely removed; Topcoat F (Mil-P-23236 Qualified)						
Surface Preparation Initial: SSPC SP-10			Secondary: Primer completely removed, SSPC SP-10			Total Dry Film Thickness: 9-17 mils
Surface Graded	ASTM D-610 Rust	ASTM F1130 Inspection	ASTM D-714 Blistering	CLER Condition	Edge Failure	Remarks
Top - Flat	8S	1B	None	1	None	
Top - Stiffener	9S	1B	None	1	None	Crack at weld, backside, and one inch long.
Top - Fill Port	3G	4S	None	1	None	
Back - Flats	10	0	None	1	None	
Back - Stiffener (HP)	9S(T)/3G(B)	8Q	None	1	None	
Bottom - Flats	9S	1B	None	1	None	
Bottom - Stiffener	10	0	None	1	None	
Bottom - Drain	10	0	None	1	None	Minor staining
Right Side - Flat	9S	1B	None	1	None	
Left Side - Flat	10	0	None	1	None	
Side Structure	8S	1B	None	1	None	
Front Flat	8G	1B	4M	1	None	Blistering limited to hatch area only, low thickness.
Hatch	9S	1B	6M	1	None	Blistering limited to bottom edge.
Additional Remarks: Some cracking, but very minor (one place).

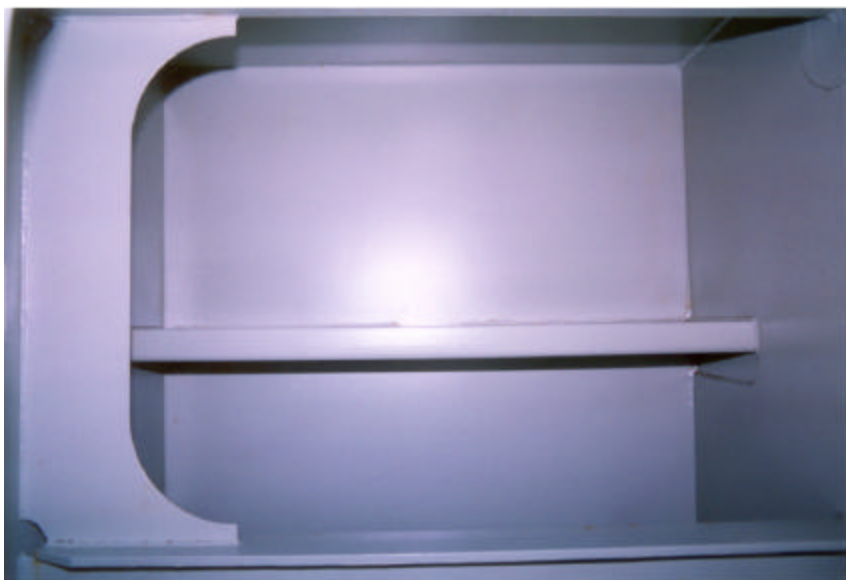
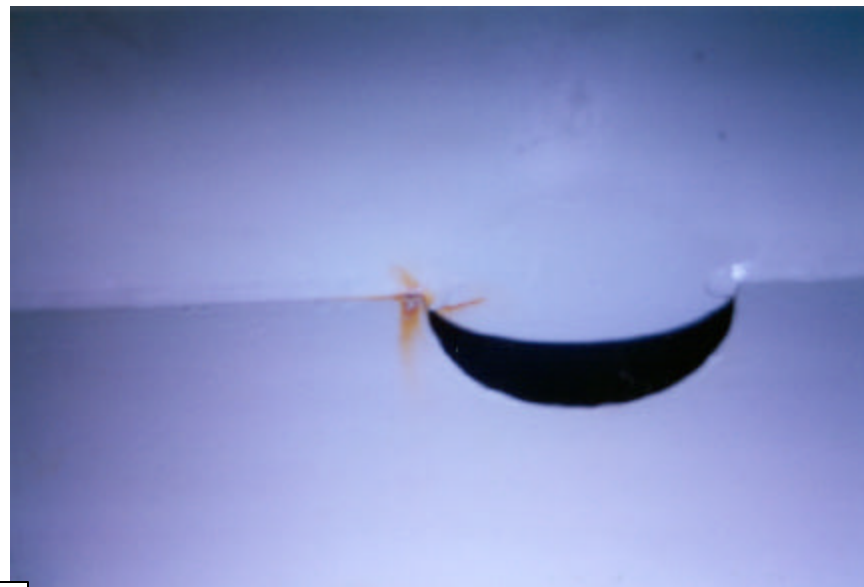
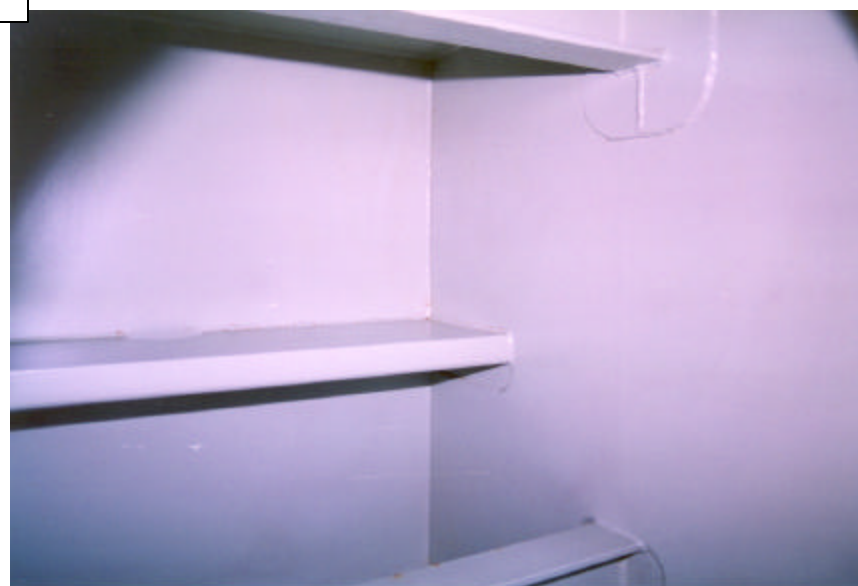
Tank D-1

Tank D was pre-primed with a PCP, which contained 49% zinc in the dry film. This was a solvent-based product. Cell D-1 was topcoated with a 67% solids material supplied by the same company as the PCP. This is the same system as applied over a different manufacturer's PCP in Cell A-3. The topcoat was tested and qualified by MARINTEK. Excellent performance was demonstrated in both Cells D-1 and A-3. Two points can be drawn from this. One is that the PCP does not degrade performance and second, high solids materials do not necessarily provide superior performance. The primary key is selecting a proven product and proper application with attention to detail.

<b>Tank D-1- Primer #4 (49% Zinc) &amp; Topcoat C (67% Volume Solids) From Same Supplier</b>						
<b>Surface Preparation Initial: SSPC SP-10</b>			<b>Secondary: Power Tool, SSPC SP-3</b>			<b>Total Dry Film Thickness: 10-17 mils</b>
<b>Surface Graded</b>	<b>ASTM D-610 Rust</b>	<b>ASTM F1130 Inspection</b>	<b>ASTM D-714 Blistering</b>	<b>CLER Condition</b>	<b>Edge Failure</b>	<b>Remarks</b>
Top - Flat	10	0	None	1	None	
Top - Stiffener	9S	1B	None	1	None	One spot at weld, undercutting.
Top - Fill Port	4G	4S	None	2	None	Failure limited to threads.
Back - Flats	10	0	None	1	None	
Back - Stiffener (HP)	10	0	None	1	None	
Bottom - Flats	9S	1B	None	1	None	One pin hole at drain hole.
Bottom - Stiffener	9S	1B	None	1	None	Limited to staining.
Bottom - Drain	9S	1B	None	1	None	
Right Side - Flat	10	0	None	1	None	
Left Side - Flat	10	0	None	1	None	
Side Structure	10	0	None	1	None	Mechanical damage
Front Flat	10	0	None	1	None

Hatch	10	0	None	1	None	Rust staining only.
Additional Remarks:

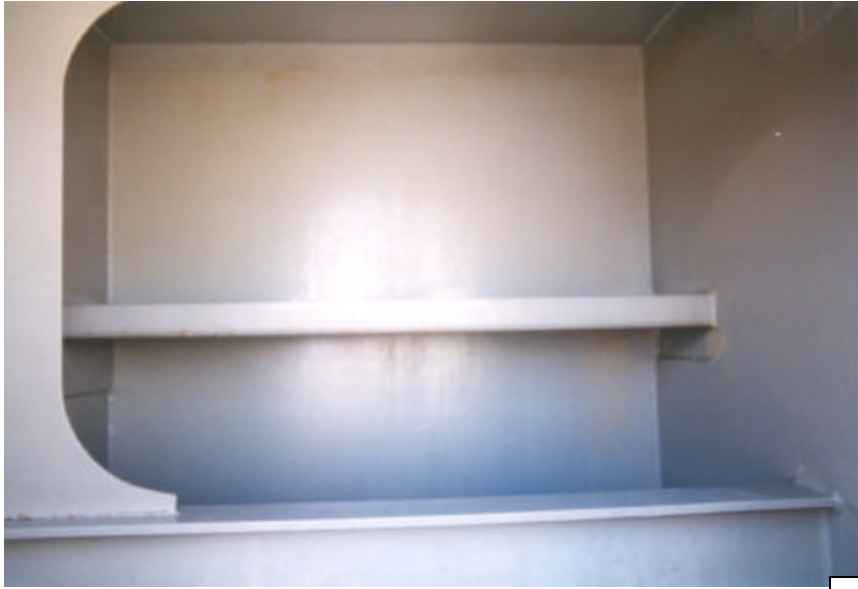
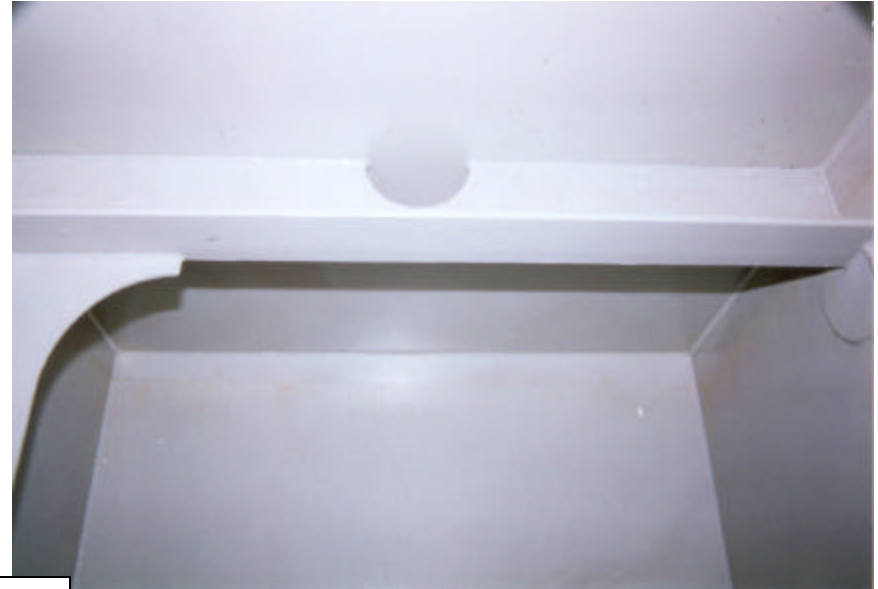
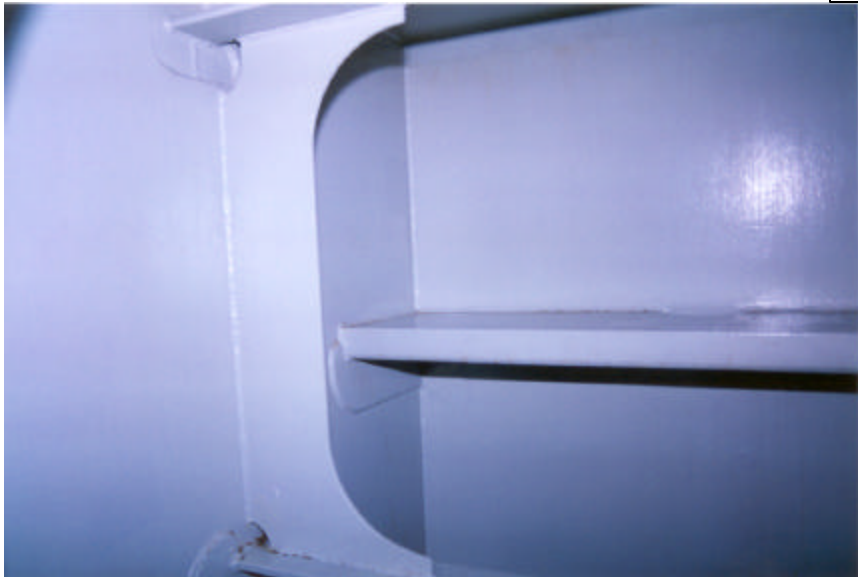
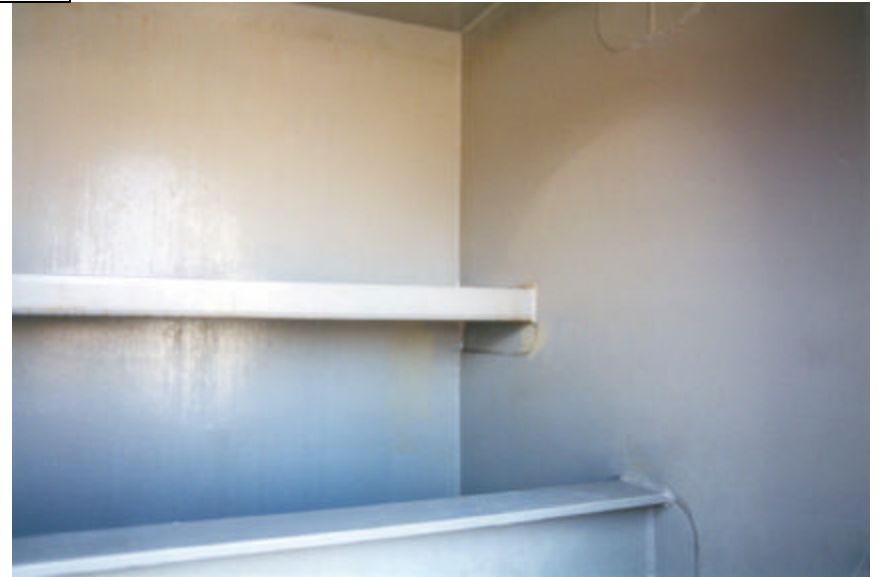
Tank D-2

Cell D-2 was topcoated with the same product as applied in Cell A-1. As with Cells D-1 and A-3, excellence performance was repeated in both Cells D-2 and A-1. Failure was limited to a few pinholes and mechanical damage.

<b>Tank D-2- Primer #4 (49% Zinc) &amp; Topcoat A (93% Volume Solids)</b>						
<b>Surface Preparation Initial: SSPC SP-10</b>			<b>Secondary: Power Tool, SSPC SP-3</b>			<b>Total Dry Film Thickness: 11-20 mils</b>
<b>Surface Graded</b>	<b>ASTM D-610 Rust</b>	<b>ASTM F1130 Inspection</b>	<b>ASTM D-714 Blistering</b>	<b>CLER Condition</b>	<b>Edge Failure</b>	<b>Remarks</b>
Top - Flat	10	0	None	1	None	
Top - Stiffener	10	0	None	1	None	
Top - Fill Port	10	0	None	1	None	
Back - Flats	10	0	None	1	None	
Back - Stiffener (HP)	10	0	None	1	None	
Bottom - Flats	9S	1B	None	1	None	
Bottom - Stiffener	10	0	None	1	None	
Bottom - Drain	10	0	None	1	None	Rust staining only.
Right Side - Flat	9S	1B	None	1	None	One small pin hole.
Left Side - Flat	10	0	None	1	None	
Side Structure	10	0	None	1	None	
Front Flat	10	0	None	1	None	Mechanical damage
Hatch	10	0	None	1	None	Rust staining only.
Additional Remarks:
